6. Item:	7. Description:	8. Part Number:	9. Quantity:	10. Serial Number:	11. Status/Work:	
1	COLLINS FLT CTL PNL FCP-65	622-5798-008	1 each	4596	REPAIRED

Teardown/Repair Report

Work Order No:	510179
----------------	---------------

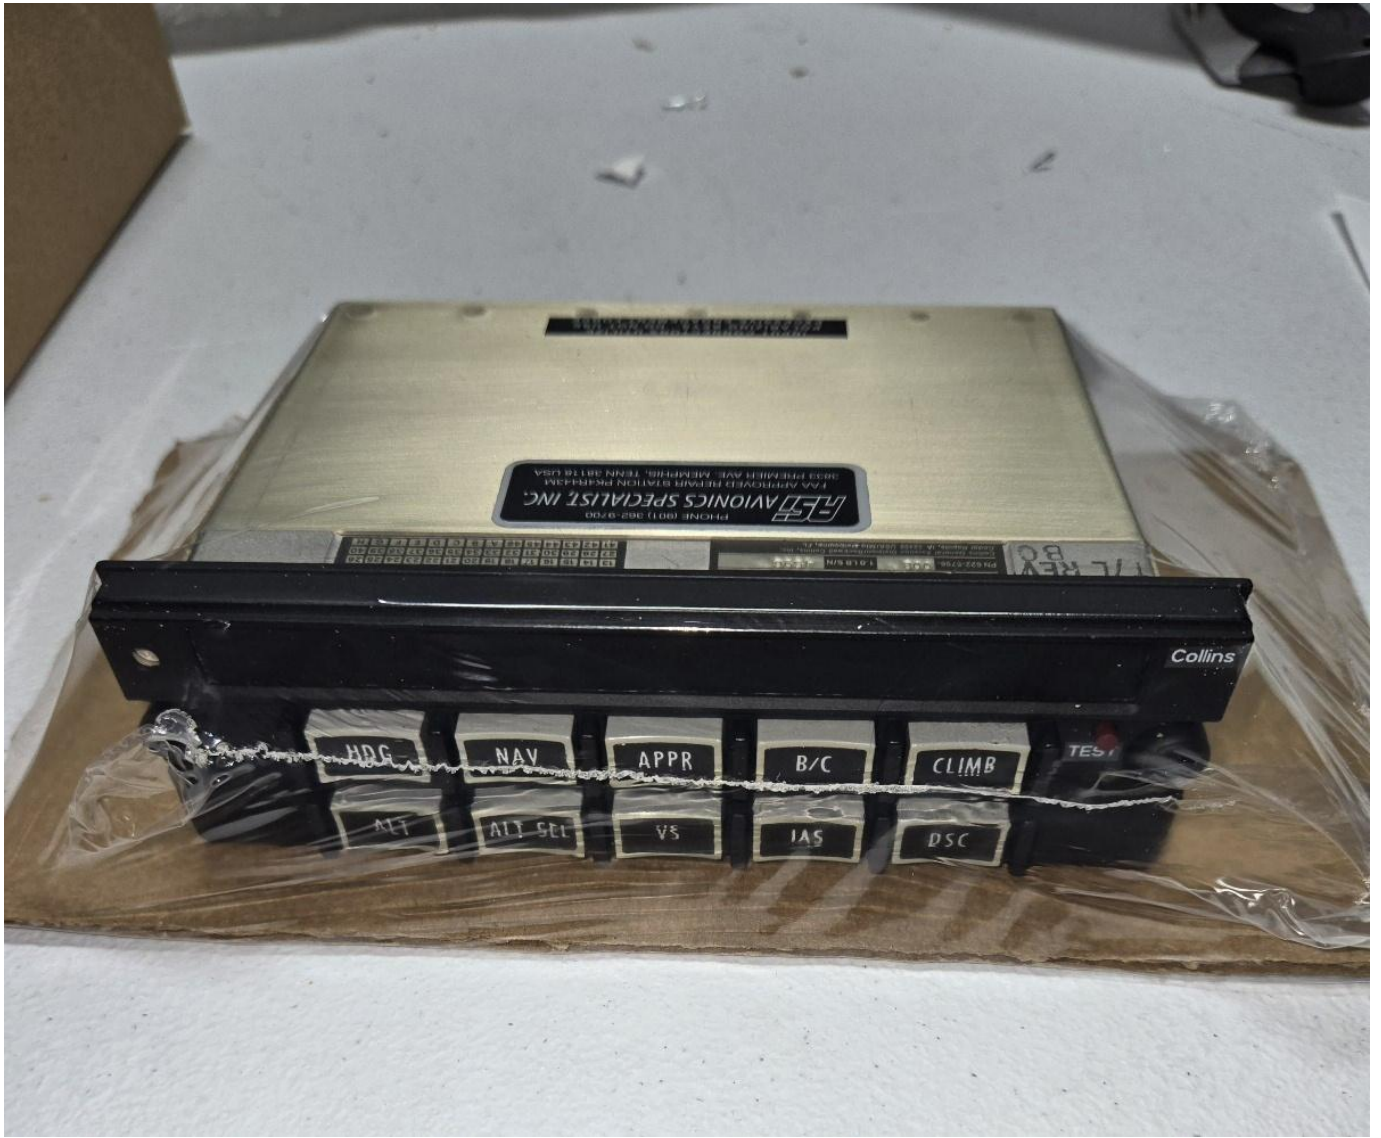
BENCH CHECKED UNIT FOUND MULTIPLE ANNUNCIATORS INOPERATIVE. ANNUNCIATOR TEST INTERMITTENT AND ANNUNCIATOR DIMMING INOPERATIVE. INSPECTED UNIT FOUND LEAKING CAPACITORS, MULTIPLE OPEN LAMPS, TEST SWITCH INTERMITTENT AND PHOTO CELL SHORTED. RE-LAMPED UNIT FOR PROLONGED LAMP RELIABILITY. REPLACED PARTS LISTED. CLEANED AND REFURBISHED UNIT AS NECESSARY. REPAIRED UNIT USING COLLINS CMM #523-0771879 6TH EDITION DATED 04-14-1998.

Cond	Description	Part Number	Alternate P/N	S/N	Qty	Unit Price	Extended
N/A	Technical Data.				1		
N/A	Miscellaneous hardware and materials.				1		
FN	IC	ULN2803A			3		
FN	CAPACITOR	183-1277-350			1		
FN	CAPACITOR	183-1277-700			1		
FN	SWITCH, PUSH	266-6034-000			1		
FN	CELL,	353-0445-020			1		
FN	LAMP	262-0136-010			31
