EXCITER - IGNITION

## TEARDOWN/ANALYSIS REPORT

Customer: Aviation Spares Intl  
 Customer Agent: Amauri Izquierdo  
 Part Number: 10-621630-1  
 Part Nomenclature: Exciter  
 Removed From: AVIATION SPARES INTL STOCK  
 Time on Part: NTC  
 Defect Reported: AIRWORTHINESS INSPECTION  
 Defect Confirmed?: N/A  
 Shop Inspection/Test Findings: FUNCTIONAL TESTED OK  
 Work Accomplished: TESTED in accordance with CMM 74-11-04, REV 9, dated 30 Sep 2011  
 REPLACED H.F. BUTTON, RETESTED OK

Serial number: ASGCAJ4528  
 Manufacturer: UNISON  
 Customer's RO: 00428  
 Date received: 31/Aug/2018  
 ATA Code: 74

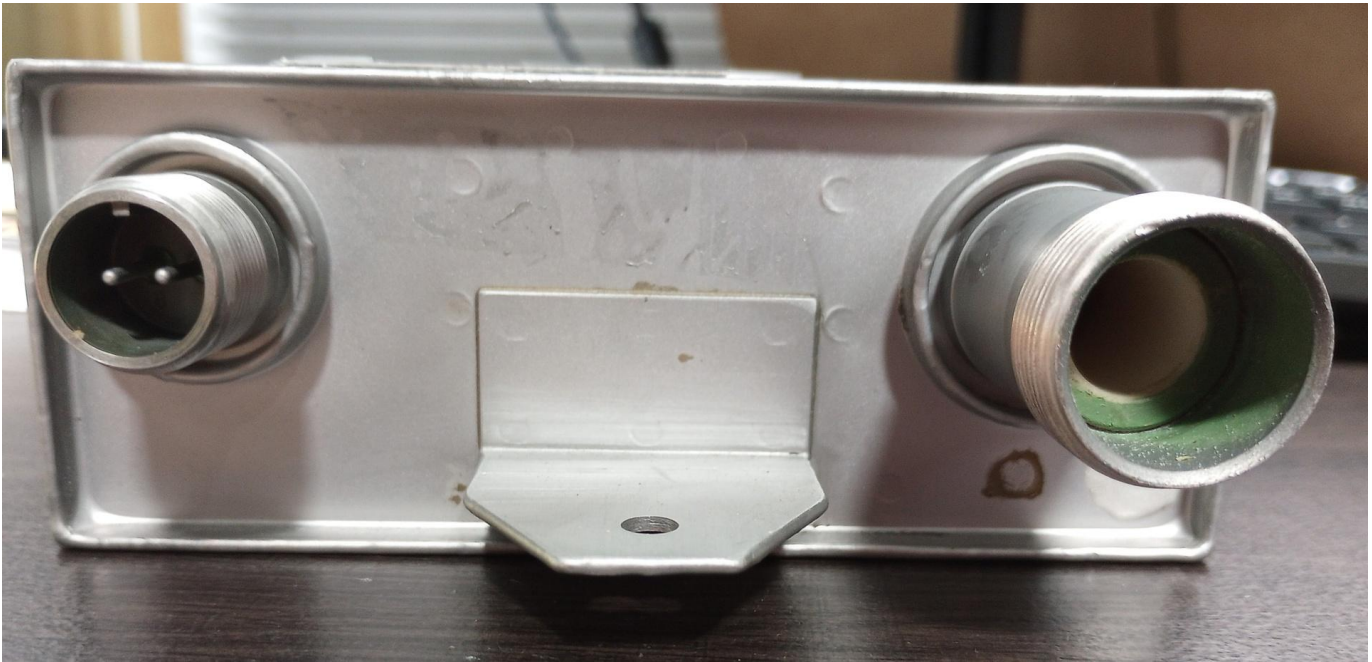
P/N: 10-621630-1 D  
S/N: ASGCAJ4528

TYPE: TFN-29  
VOLTS: 90-124 VAC  
AMPS: 1.5 MAX  
DUTY: CONTINUOUS

6. Item:	7. Description:	8. Part Number:	9. Quantity:	10. Serial Number:	11. Status/Work:	
1	Exciter UNISON	10-621630-1	1	ASGCAJ4528	TESTED	
12. Remarks: TESTED in accordance with CMM 74-11-04, REV 9, dated 30 Sep 2011 REPLACED H.F. BUTTON, RETESTED OK  See Teardown/Analysis Report for further details  Certifies that the work specified in Blocks 11/12 was carried out in accordance with EASA part 145, and in respect to that work, the component is considered ready for release to service under EASA Part 145 Approval Number EASA.145.4164.						
13a. Certifies the items identified above were manufactured in conformity to:  <input type="checkbox"/> Approved design data and are in a condition for safe operation.  <input type="checkbox"/> Non-approved design data specified in Block 12.				14a. <input checked="" type="checkbox"/> 14 CFR 43.9 Return to Service <input checked="" type="checkbox"/> Other regulation specified in Block 12  Certifies that unless otherwise specified in Block 12, the work identified in block 11 and described in Block 12 was accomplished in accordance with Title 14, Code of Federal Regulations, part 43 and in respect to that work the items are approved for return to service.
