**BER / Scrap Notice**

Work Order : TCA4153  
PN : 7514081-911  
Serial : ANE41560  
Date Printed : 6/25/2025

Code : PPNS  
Descr : TCAS ANTENNA

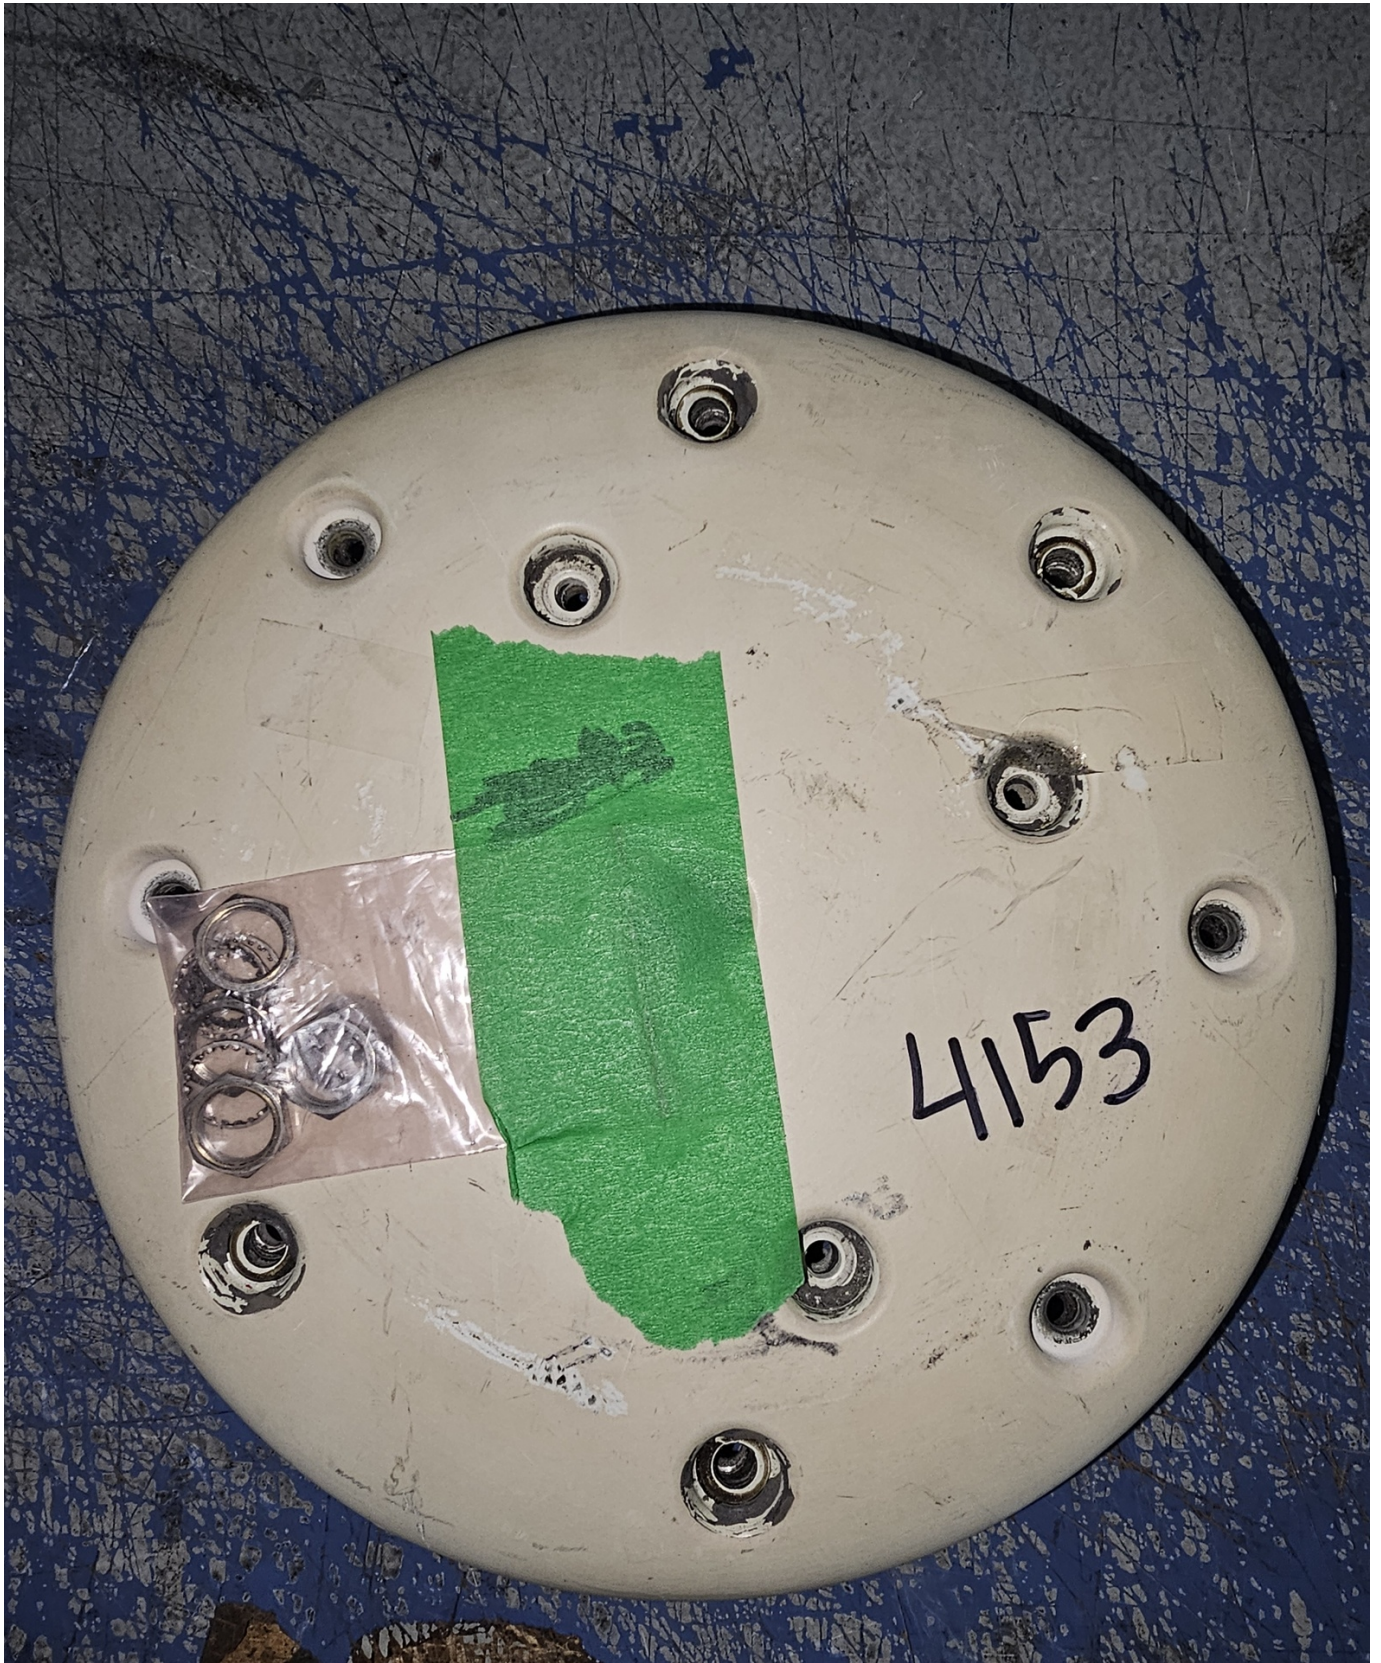
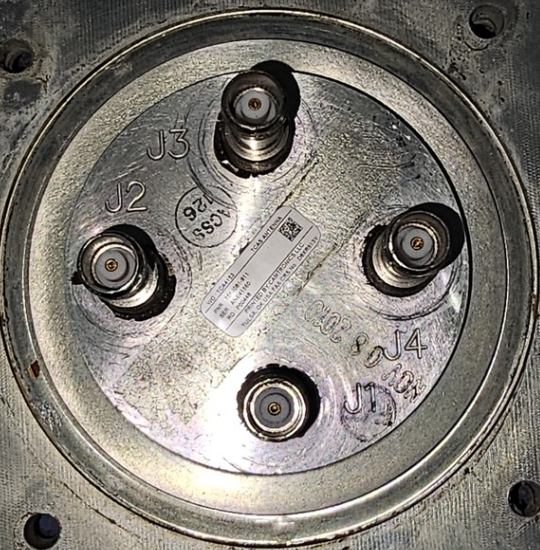
Unit was inspected to the level necessary to isolate external faults. Unit exhibited wear, tear, and sealant around the mounting holes and edges around the unit (i.e., worn exterior radome and paint.) typical of in-service conditions.

Radome separation from adapter plate, very high possibility of water intrusion. Reason or cause of antenna failure. Overhaul required IAW CAM-4081.

**\*\*Due to PCB degradation, unit is considered non-repairable and cannot be returned to service IAW CAM-4081. Recommend scrap\*\***
