EXCITER - IGNITION

P/N: 10-621630-1 D
S/N: ASGCAJ4528

1. Approving Civil Aviation Authority/Country: FAA/UNITED STATES		2. AUTHORIZED RELEASE CERTIFICATE FAA Form 8130-3, AIRWORTHINESS APPROVAL TAG		3. Form Tracking Number: 213908

6. Item:	7. Description:	8. Part Number:	9. Quantity:	10. Serial Number:	11. Status/Work:
1	Exciter UNISON	10-621630-1	1	ASGCAJ4528	TESTED
12. Remarks: TESTED in accordance with CMM 74-11-04, REV 9, dated 30 Sep 2011 REPLACED H.F. BUTTON, RETESTED OK See Teardown/Analysis Report for further details Certifies that the work specified in Blocks 11/12 was carried out in accordance with EASA part 145, and in respect to that work, the component is considered ready for release to service under EASA Part 145 Approval Number EASA.145.4164.					
13a. Certifies the items identified above were manufactured in conformity to: <input type="checkbox"/> Approved design data and are in a condition for safe operation. <input type="checkbox"/> Non-approved design data specified in Block 12.			14a. <input checked="" type="checkbox"/> 14 CFR 43.9 Return to Service <input checked="" type="checkbox"/> Other regulation specified in Block 12 Certifies that unless otherwise spec

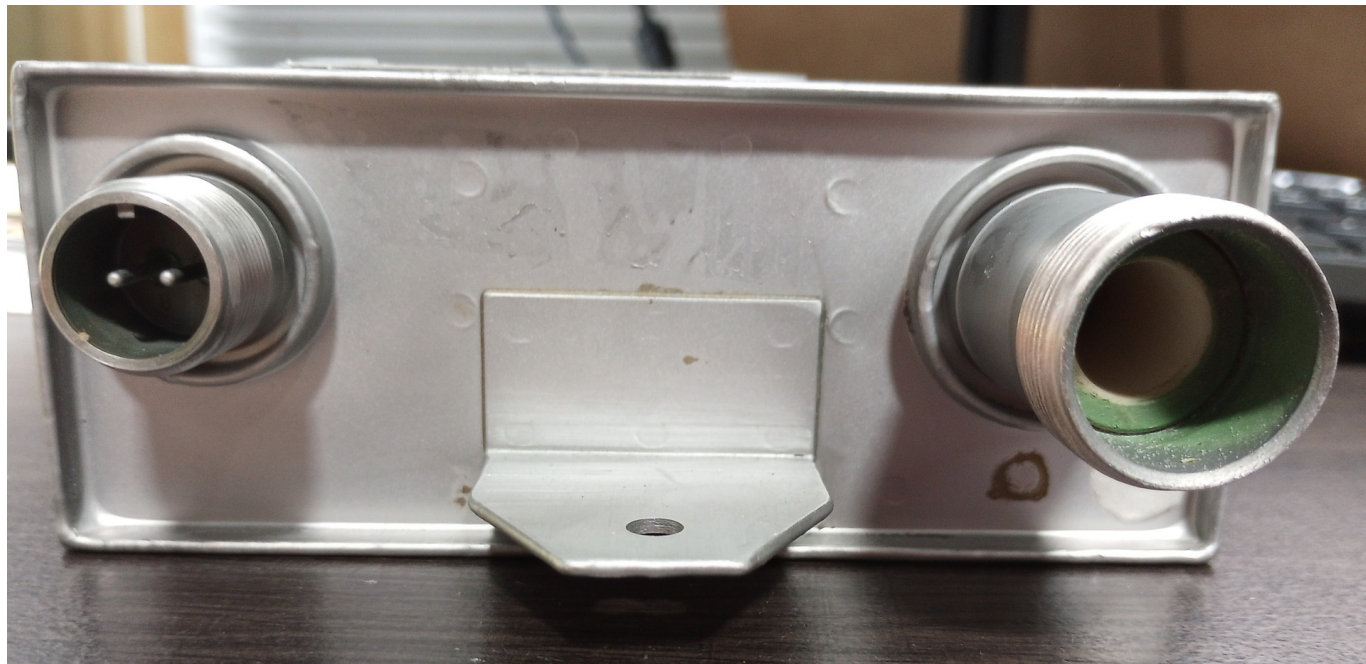
TYPE: TFN-29
VOLTS: 90-124 VAC
AMPS: 1.5 MAX
DUTY: CONTINUOUS

Customer: Aviation Spares Intl
Customer Agent: Amauri Izquierdo
Part Number: 10-621630-1
Part Nomenclature: Exciter
Removed From: AVIATION SPARES INTL STOCK
Time on Part: NTC
Defect Reported: AIRWORTHINESS INSPECTION
Defect Confirmed?: N/A
Shop Inspection/Test Findings: FUNCTIONAL TESTED OK
Work Accomplished: REPLACED H.F. BUTTON, RETESTED OK
